This new proposal is a departure from the low-tech approach because of the proposed use of excavators to re-shape the floodplain and topple vegetation. Please provide more specifics about the scope of disturbance and the topsoil management objectives.

We understand that the proposed work can seem like a departure from the original low-tech process-based restoration (LTPBR) that we initiated in the Asotin IMW back in 2012. However, we feel it is completely consistent with the LTPBR adaptive management framework we used to implement restoration. We plan to preserve the intent of LTPBR - namely to restrain the use of heavy equipment to the minimal amount required to open up key sections of the floodplain as identified by the relative elevation model (see below). We visited a proof-of-concept site on the SRFB tour on May 2 where we had opened up a berm by hand. We are proposing the same process but with minimal intervention using a small excavator. The opening in the berms will be 10-30 feet wide and scaled based on the size of the stream (Table 1). The berms are generally made up of coarse gravels and cobbles with very little topsoil. If topsoil is present, we will remove the topsoil

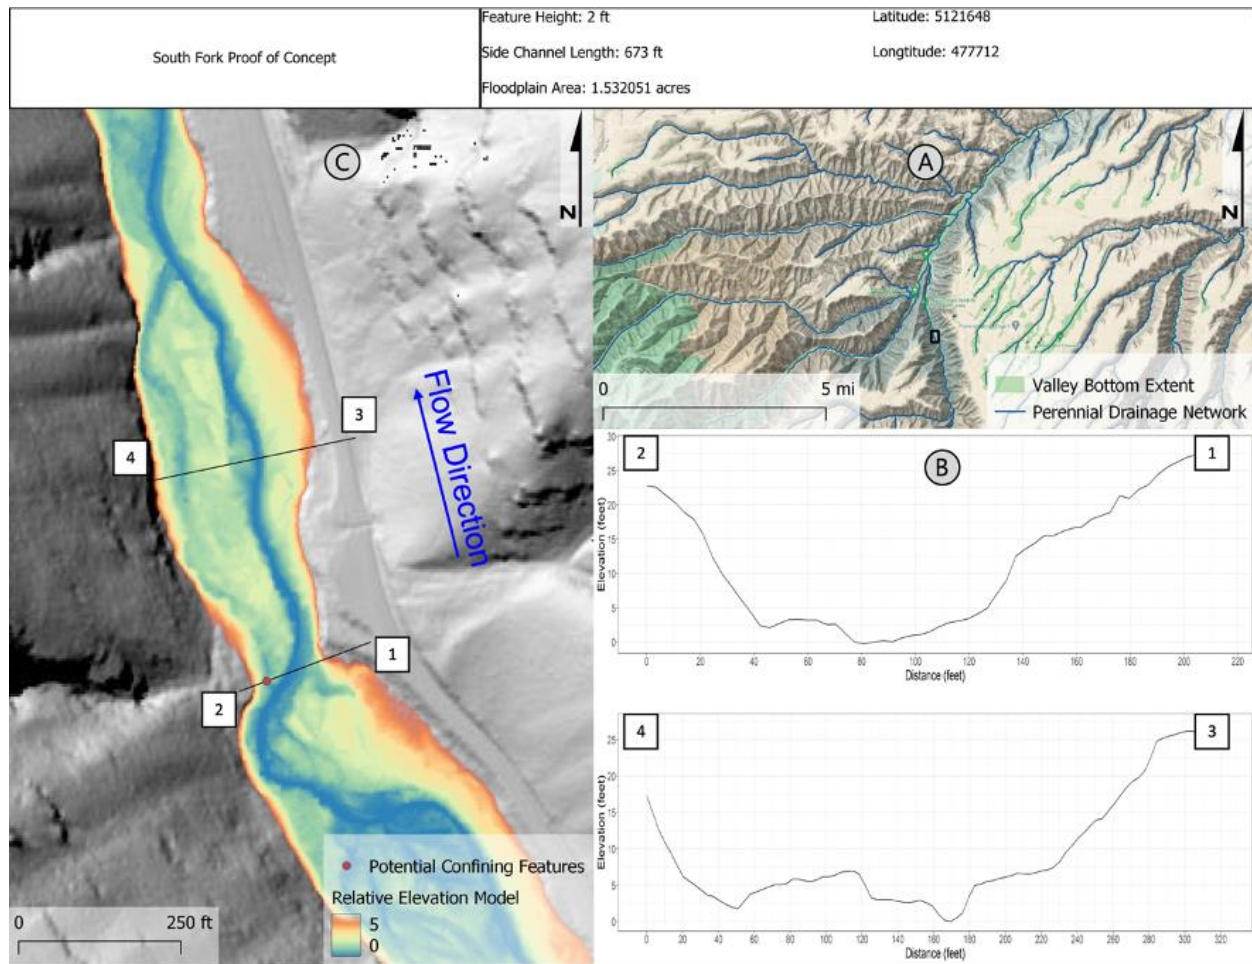
Figure 1. North Fork Asotin Creek proof of concept where we connected a historic side-channel by hand digging a berm down and installing a beaver dam analog to force water into the side-channel. Panels A identifies the location of site (black box), Panel B provides a cross-section at the confining feature (from points 1-2) and a cross-section across the recently connected side-channel and floodplain (from points 3-4).

A typical depiction of what we are proposing is best described by the proof-of-concept site we visited on May 2 and the Basis of Design Report we provided in PRISM (page 11). In 2021-2022, we identified one confining berm through field observations in North Fork Asotin Creek. The berm was cutting off almost 700 feet of side-channel and 1.5 acres of floodplain habitat (Figure 1). We opened the berm at the head of historic side-channels by digging by hand and installed structures in the mainstem to back water up to the openings in the berms (Figure 2). However, it took several days with a crew of 3-5 to open the berm by hand digging and we could not fully open the berm (i.e., dig down the elevation of the mouth of the side-channel to the same elevation of the main channel) due to tree roots and large substrate (Figure 2). We propose to replicate this activity but use a mini excavator to speed up the process and allow us to dig deeper to connect the side-channels and floodplain at the same elevation as the existing active channel to allow the connection to persist at summer low-flows.
